DATE: November 4, 2015

SUBJECT: Transmittal of Final Report - High Lead at Three Residences in Flint, Michigan

High Lead Levels in Flint, Michigan

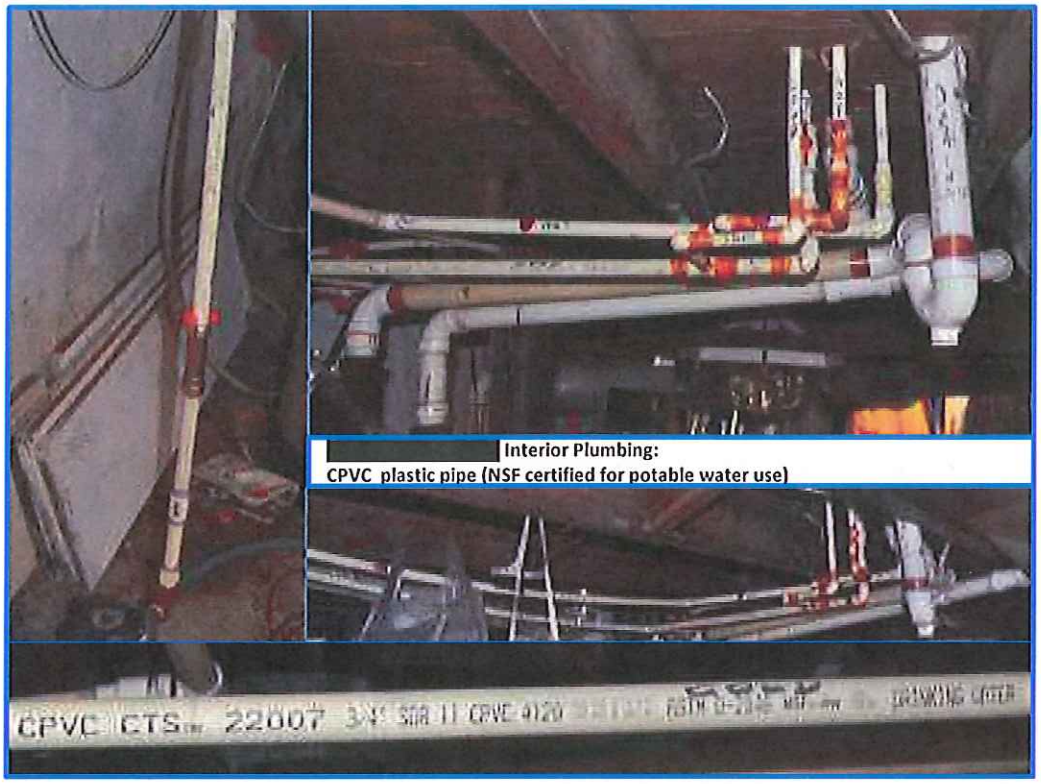
The following pictures were taken at the [redacted] home located at [redacted]. With the exception of a a few minor metallic connectors, all potable water plumbing in the home was found to be CPVC plastic pipe which is NSF-certified for drinking water use.

[redacted] Interior Plumbing:
CPVC plastic pipe (NSF certified for potable water use)

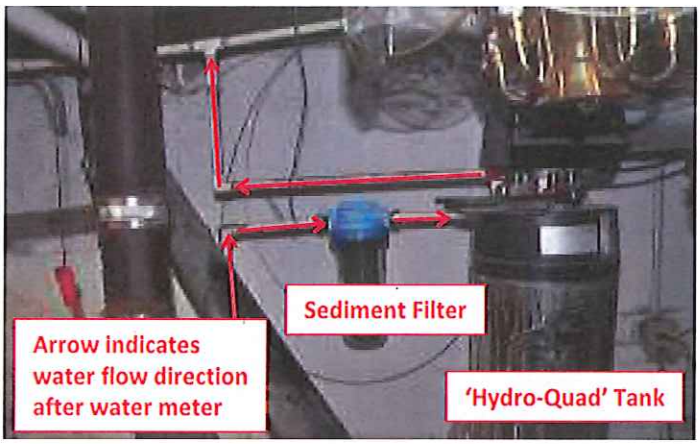
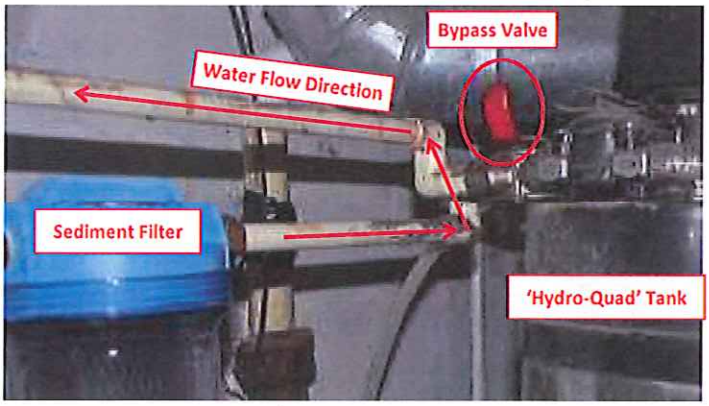
The [redacted] home has a whole-home sediment filter, as well a non-functioning 'Hydro-Quad Commercial Water Processor' which is bypassed. There was no iron filter in the home as had been previously reported.

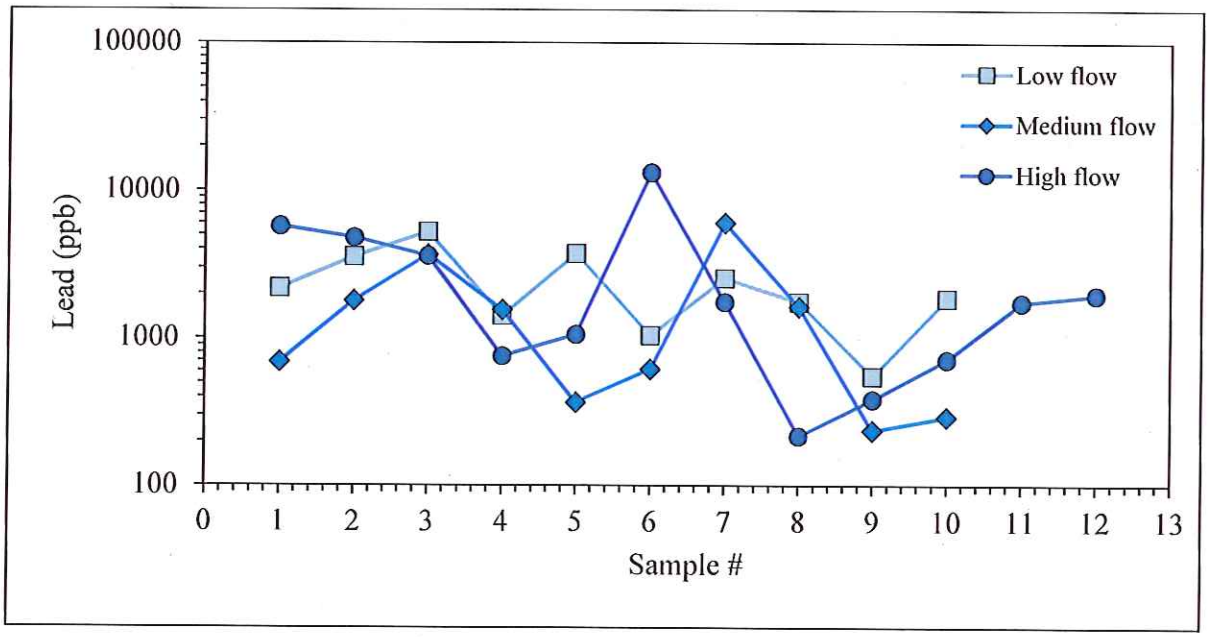
Samples were collected from the [redacted] home following an extended stagnation period (April 3, 2015 to April 27, 2014) after the water at the [redacted] residence had been shut off. The water was turned back on and three sets of sequential samples were collected on April 28, 2015, at different flow rates (low, medium and high).

Low Flow									
	1 L Sample Bottle							125 mL Sample Bottle		
Element (units)	M-1	M-2	M-3	M-4	M-5	M-6	M-7	M-21	M-22	M-23
Ag (ppb)	0	0	0	0	0	0	0	0	0	0
Al (ppb)	2,285	4,199	7,683	1,856	5,623	1,422	3,413	1,865	666	2,015
As (ppb)	3.3	3.9	4	2	3.2	2	2.6	3.6	1.9	3.1
Ba (ppb)	31.3	39.8	27.7	21.2	24.2	20.9	22.8	31.3	21.3	32.6
Ca (ppb)	43,150	43,620	43,580	42,590	43,030	42,030	42,440	40,790	41,050	41,460
Cd (ppb)	2.5	4.2	5.7	1.9	3.9	2	2.5	2.2	1.4	2.4
Cl (ppm)	1,206	1,148	1,272	1,178	1,187	1,214	1,218	1,641	1,076	1,044
Co (ppb)	1.1	1.7	0.9	0.4	0.7	0.4	0.5	0.9	0.3	1
Cr (ppb)	2.1	2.5	2.6	1.3	1.9	1.6	1.5	1.8	1.3	1.7
Cu (ppb)	235	355	294	94	146	101	112	180	82	178
Fe (ppb)	3,598	4,928	3,419	1,446	3,029	2,142	1,780	3,096	1,344	3,241
K (ppb)	3,480	3,508	3,445	3,435	3,430	3,391	3,409	3,256	3,319	3,341
Mg (ppb)	10,310	11,910	17,990	11,290	15,470	10,610	12,720	8,861	9,396	9,098
Mn (ppb)	1,734	2,790	1,093	462	703	429	652	1,382	442	1,509

Mo (ppb)	2.3	2.3	1.9	1.9	1.9	1.8	1.8	1.7	1.7	1.8
Na (ppb)	17,790	17,860	17,810	17,620	17,650	17,410	17,610	16,960	17,100	17,280
Ni (ppb)	9.8	16	30.7	8.1	23.2	6.2	15.3	6.6	3.7	6.8
P (ppb)	835	1,267	1,441	416	1,040	379	691	773	261	819
Pb (ppb)	2,171	3,550	5,224	1,412	3,735	1,038	2,542	1,759	552	1,857
S (ppm)	28.5	28.7	28.5	28.4	28.5	28	28	26	27	27.1
Se (ppb)	0.2	0	-0.1	0.1	0.2	0	0.3	0	0	0.2
Si (ppb)	3,212	5,281	12,320	4,474	9,401	3,770	6,231	2,619	2,582	2,775
Sn (ppb)	4.6	4.9	6.1	2.2	4.5	2.3	3	2.3	1.5	2.3
Sr (ppb)	129.4	132.3	128.5	125	127.7	125.3	126.1	126.3	125.5	128
Ti (ppb)	3.4	5.8	8.3	2.1	5.8	1.9	3.1	3	1.4	3.1
U (ppb)	1	1.6	2.6	0.8	1.9	0.7	1.2	0.9	0.4	0.9
V (ppb)	13.9	17.5	23.9	9.8	17.6	8.9	13.8	12.2	6	10.8
Zn (ppb)	1,055	1,848	2,731	777	1,890	839	979	746	513	808

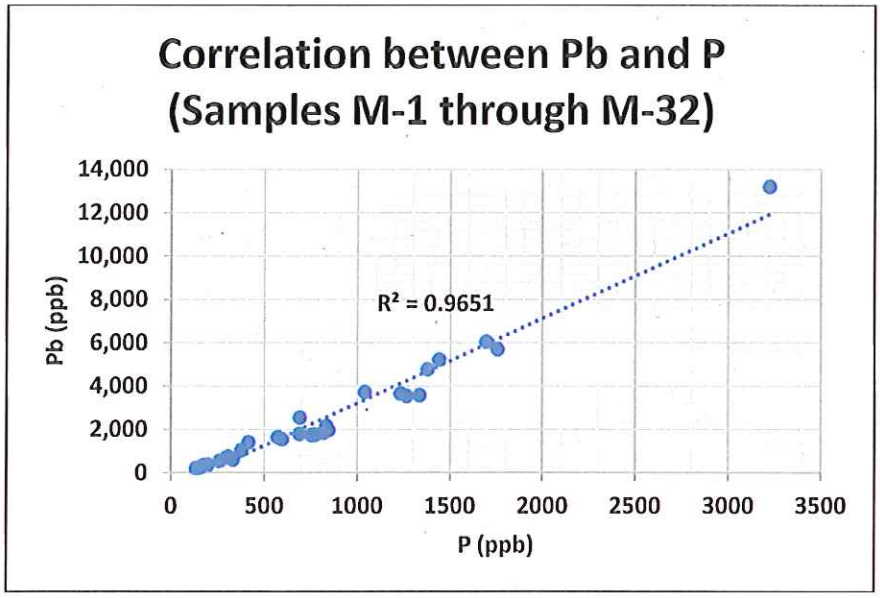
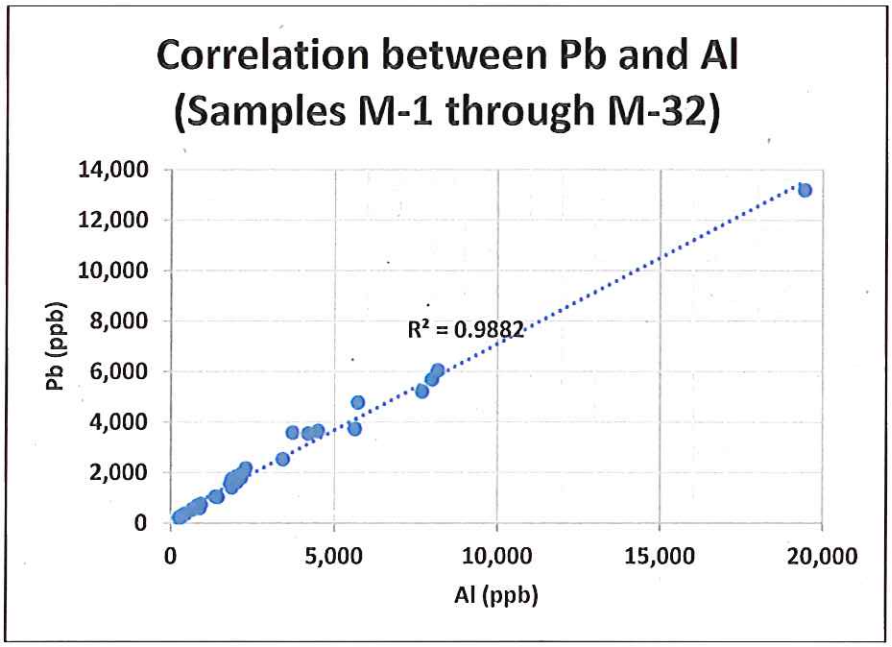
Correlation between lead, phosphorus and aluminum

The correlation of lead and phosphate, as well as lead and aluminum, indicate that the samples were captured scale and sediment that had formed inside the pipes while the City of Flint was purchasing water from Detroit. The absence of these chemicals in the current treatment provided by Flint indicate that these elements were not in the water passing through the pipes, but came from the scales inside the service line which had disintegrated into the water or were dislodged into the water.

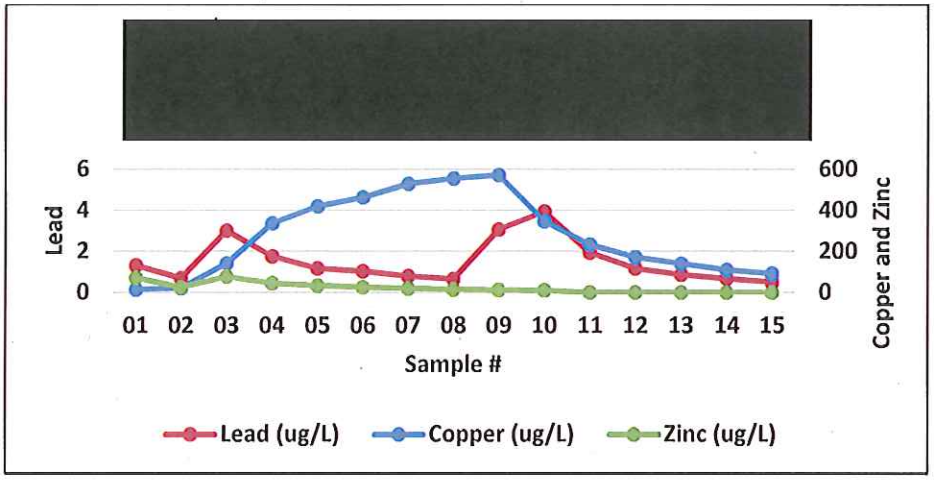
Following the replacement of the [redacted] original service line, a series of 15 sequential samples were collected from the kitchen tap to measure the lead levels and other parameters to ensure that the high lead from the original service line had not contaminated the interior plumbing at the [redacted] home. With the exception of two areas, lead levels were low throughout the [redacted] plumbing following the service line replacement. The two sources of lead that were still detected in the plumbing are likely the water meter (Sample 3) and the new external service shut-off valve (Samples 9-11). Although new brass plumbing components must be lead-free, there can still be some lead that is released from these components.

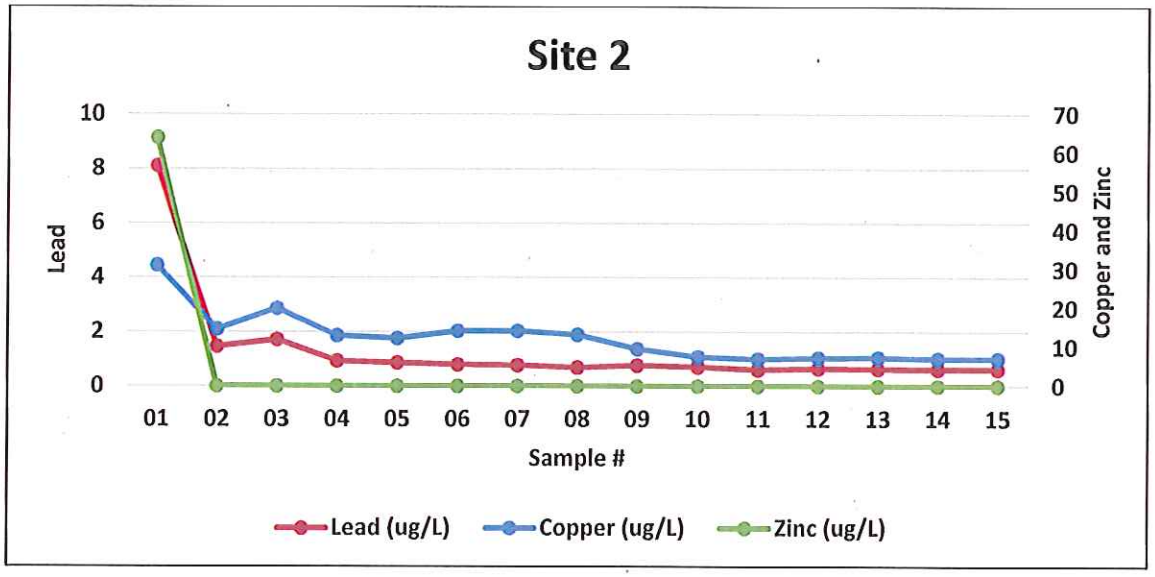
Site 2

Based on the results found at this home, it does not appear that any portion of the service line is made of lead, and as a result, the lead levels are low in most samples. The exception is in Sample 1 which reflects water within approximately 15 feet of the kitchen tap and is likely due to brass components in the faucet, underlying valves and fixtures.

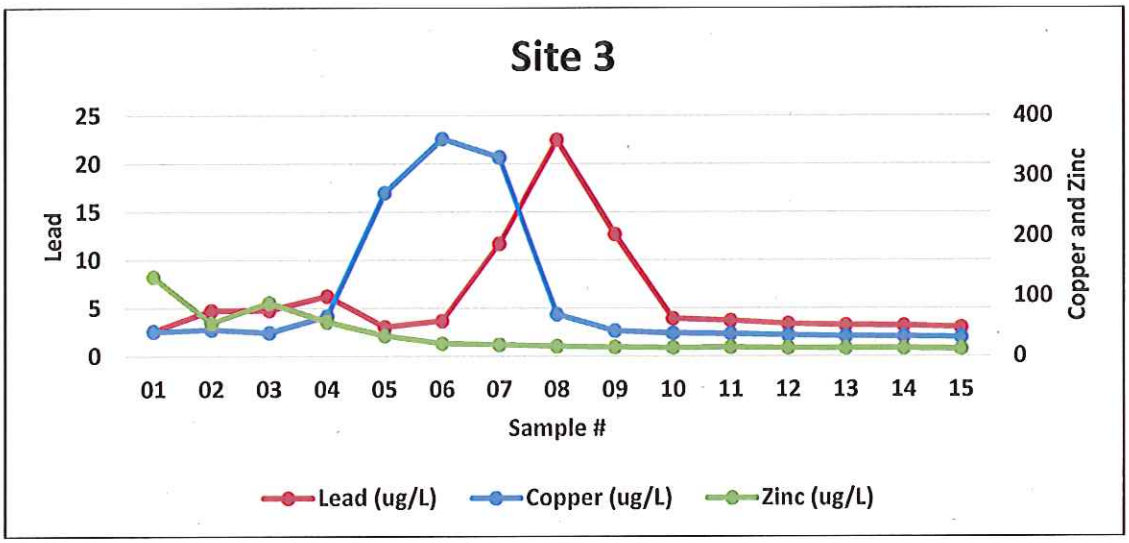
Site 3

Based on the results found at this home, it appears that the portion of the service line from the external service shut-off valve to the water main is made of lead as indicated by the increase in lead levels in samples 7 through 9.

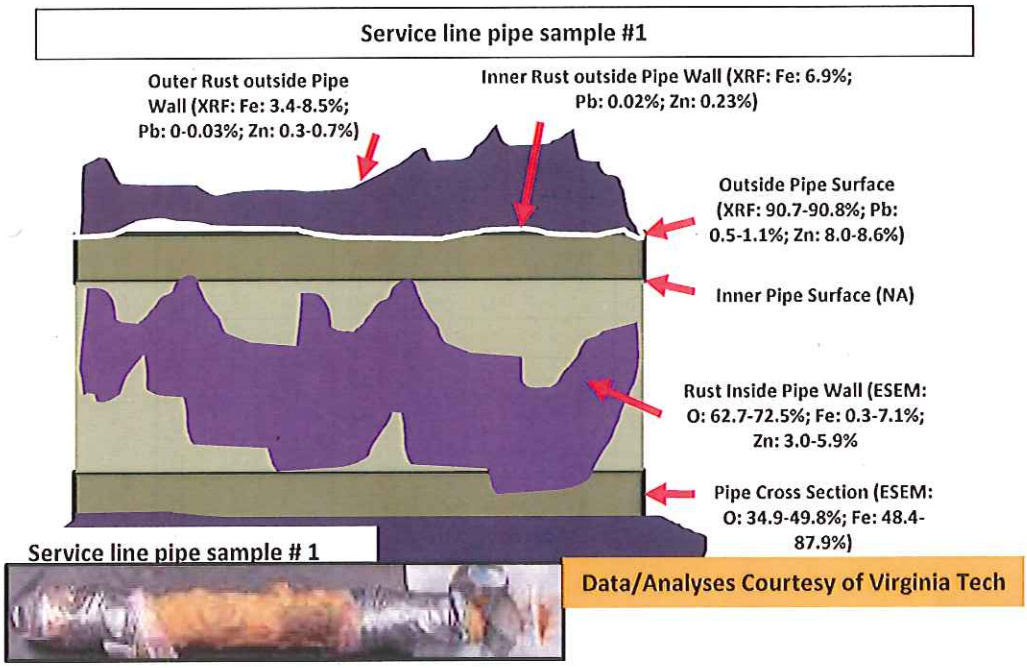
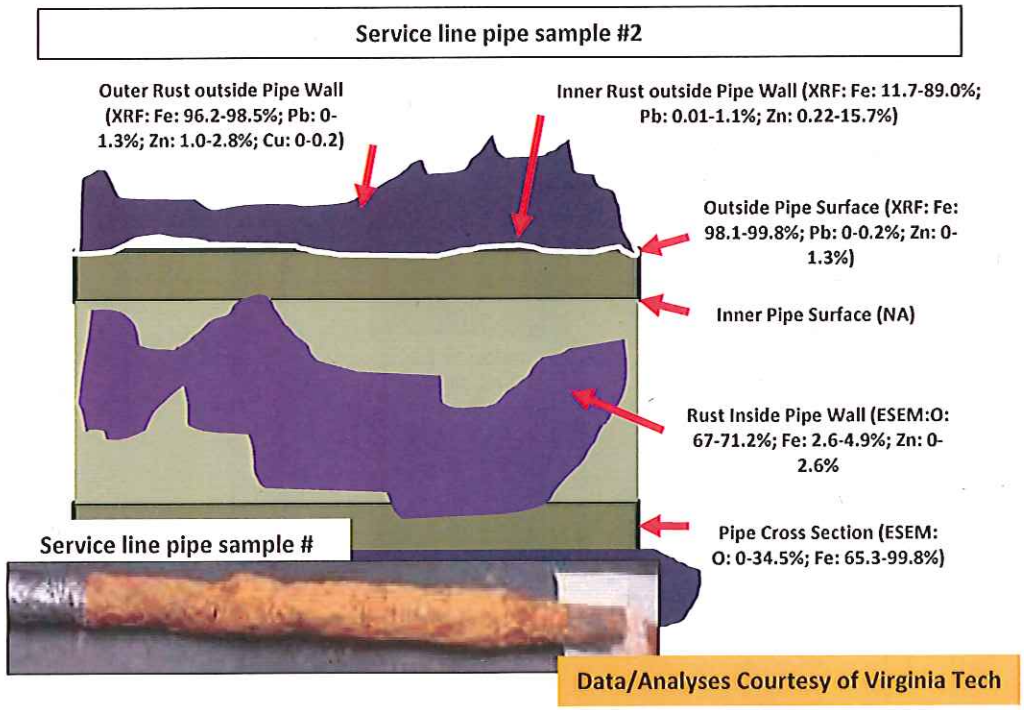
Below are the results of the galvanized pipe analyses conducted by Virginia Tech on the two sections of galvanized iron pipe from the [redacted] original service line. The analyses indicate that the [redacted] original service line was a typical galvanized iron pipe.

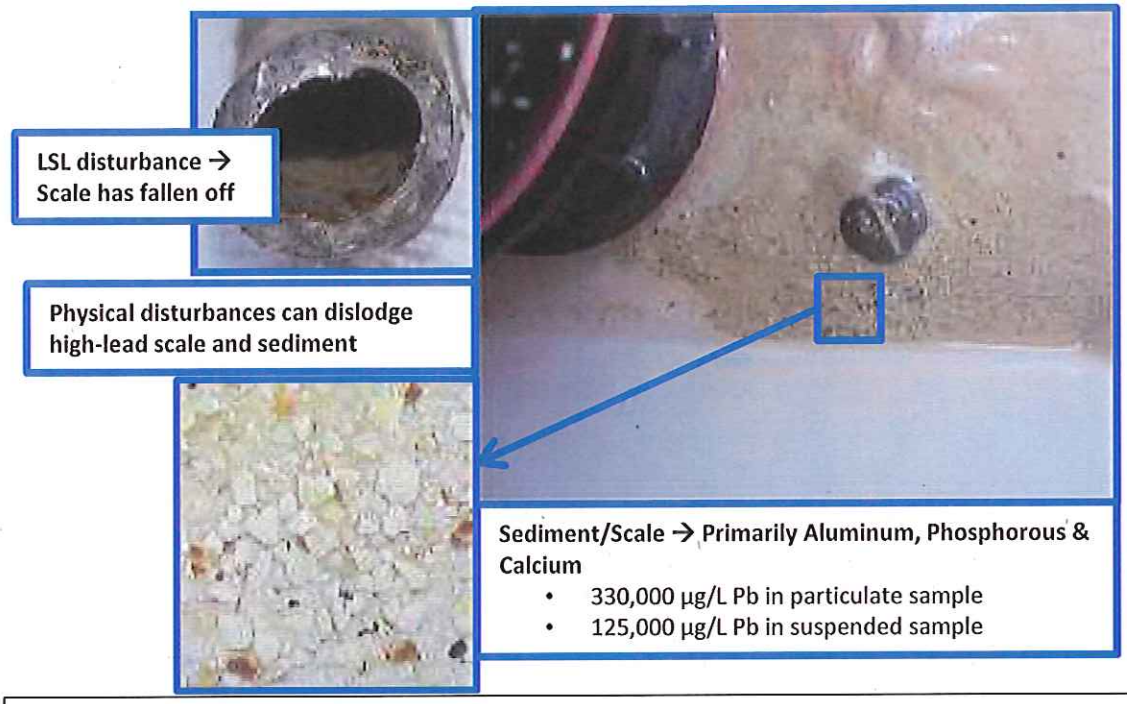
A recent EPA study indicates that physical disturbances to lead service lines or in proximity to lead service lines can cause the dislodging of the protective scales from within the lines. The photograph below shows the scale that was dislodged from inside a lead service line during routine maintenance work in another city due to a physical disturbance of the line. The dislodged scale and sediment contained a very high concentration of lead.

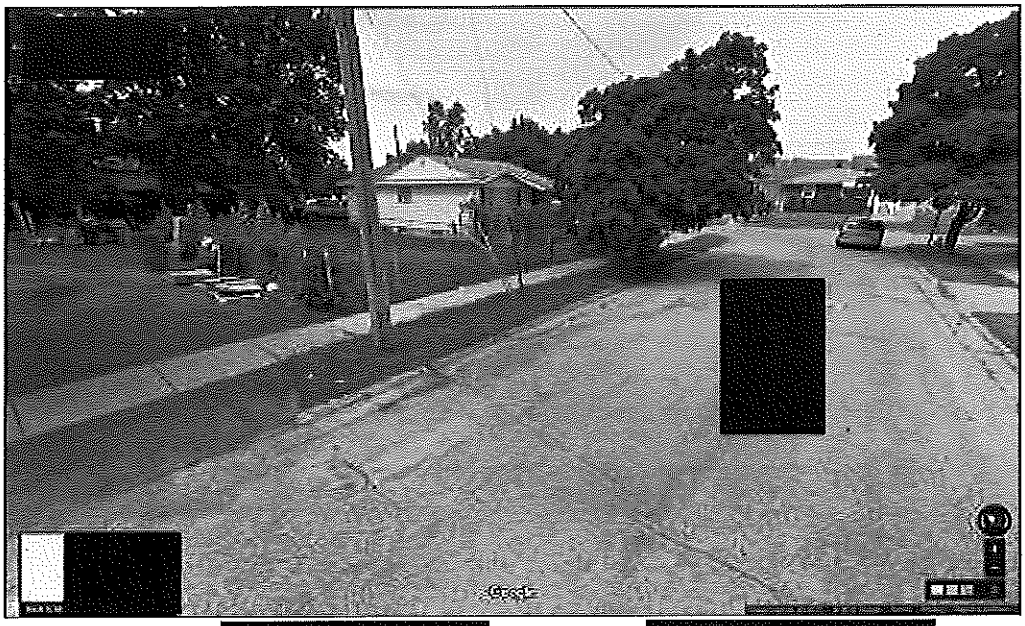
July 2011 image [redacted] (view from [redacted] toward Bryant Street).

Google 'Street View' Image 1 captured in July 2011 shows no patches in street along curb next to the parkway where the [redacted] service line runs toward Bryant Street, indicating that the physical disturbances occurred after the date this image was captured (July 2011).

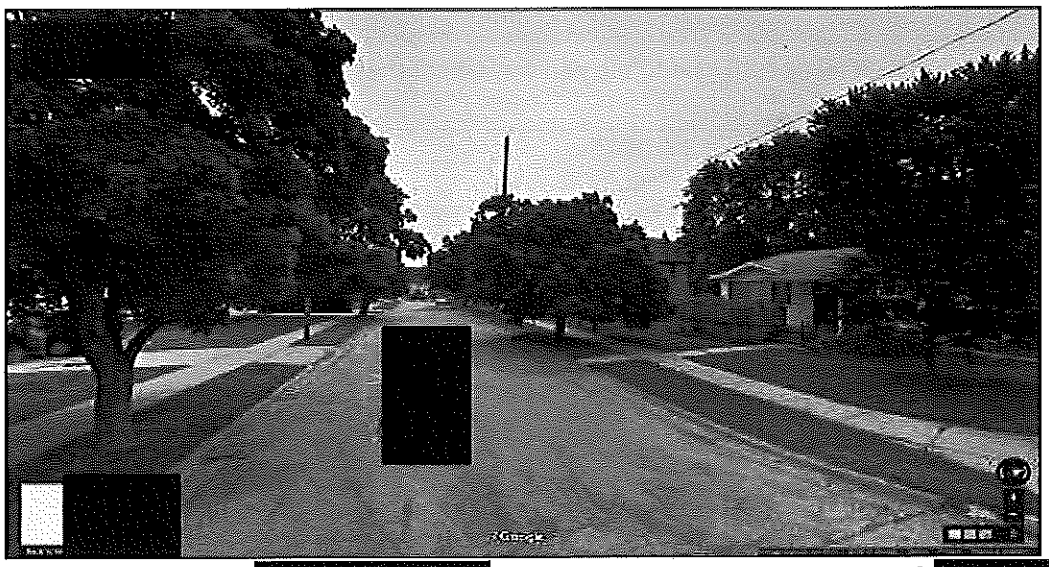
July 2011 image of [redacted] (view from Bryant Street toward [redacted]).

Google 'Street View' Image 2 captured in July 2011 shows no patches in street along curb next to the parkway where the [redacted] service line runs toward Bryant Street, indicating that the physical disturbances occurred after the date this image was captured (July 2011).
